19. Hazardous Materials

19.1. Chapter Overview

The following analysis was conducted to determine whether the new or relocated SDEIS elements that were proposed are located in an area known to be contaminated by hazardous materials and to identify any newly reported hazardous material incidents that may affect SDEIS elements unchanged from the DEIS. The summary table in Section 19.4 presents the total of potential hazardous material exposure affecting the entire Northern Branch Project.

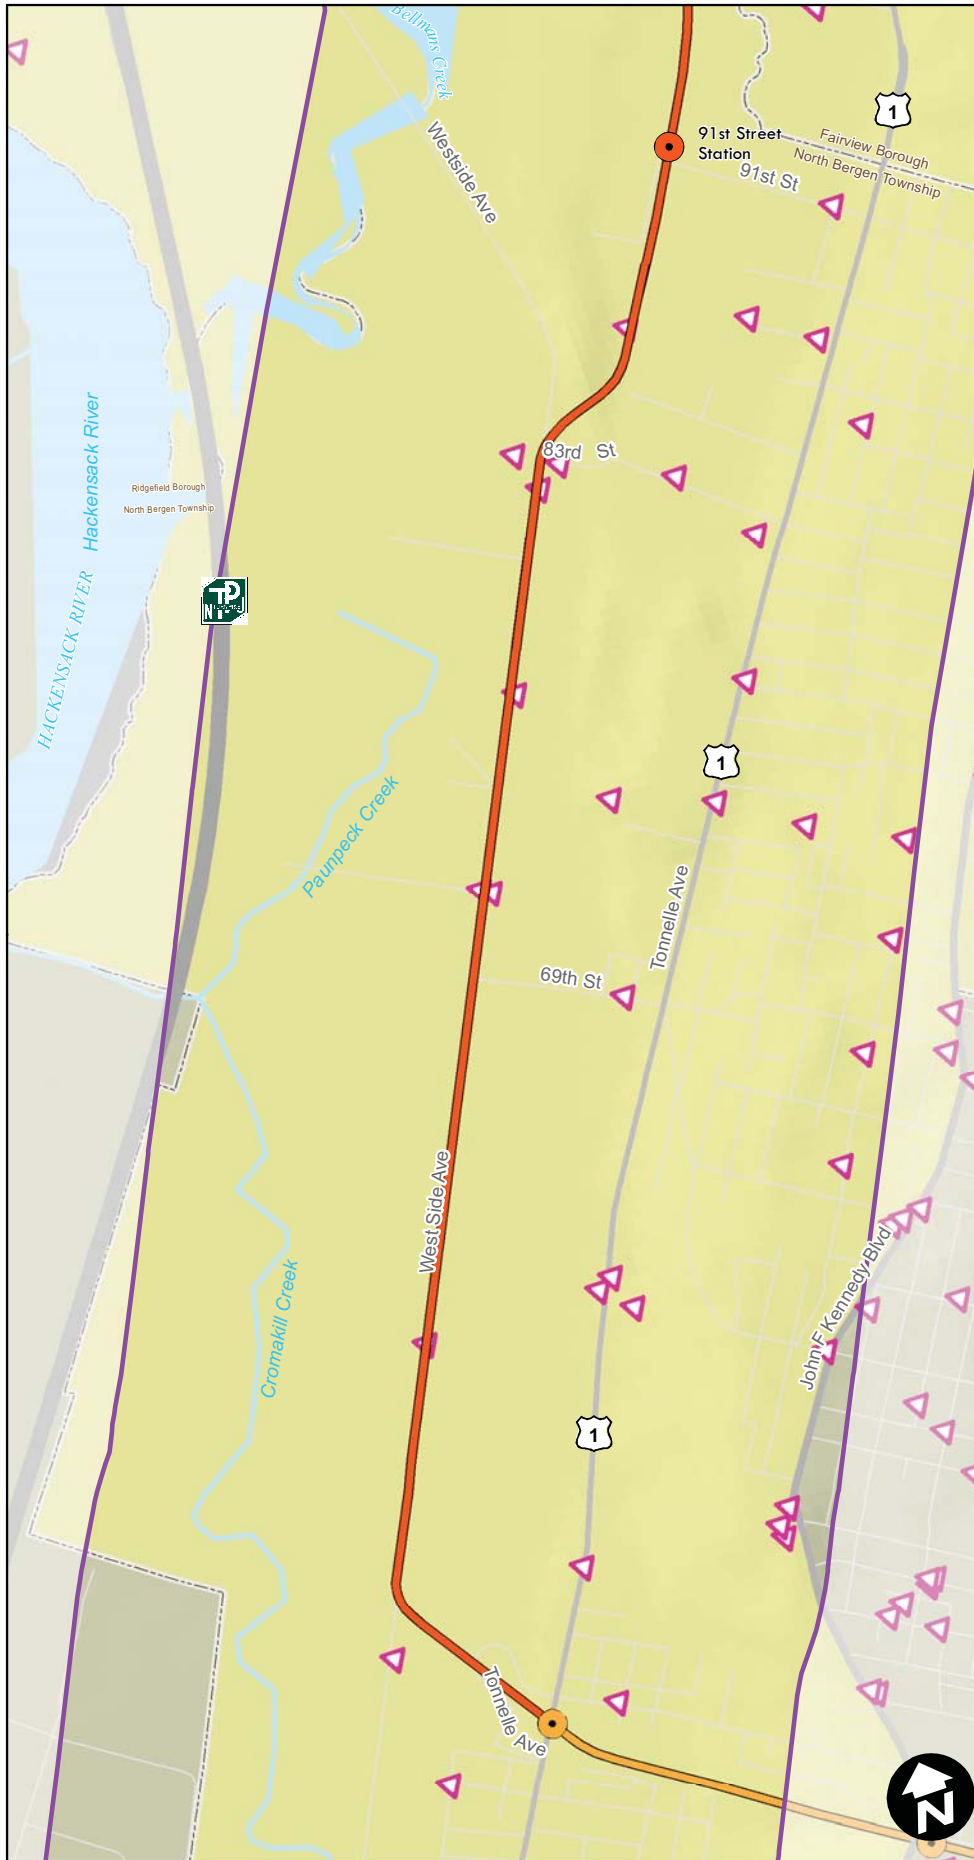
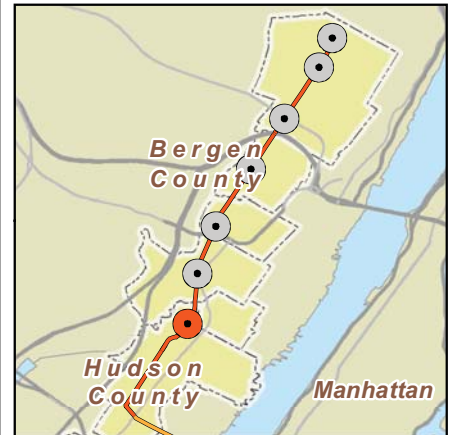
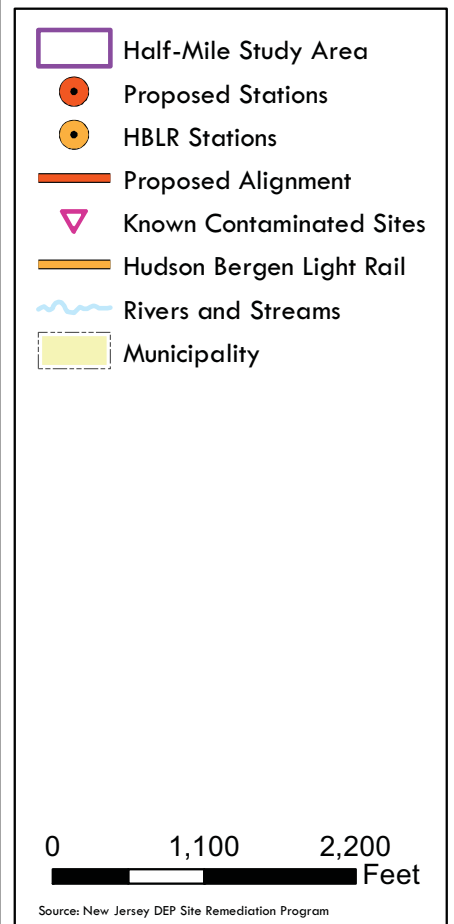
Figure 19-1

Northern Branch North Bergen & 91st Street Station Hazardous Materials Sites

Figures 19-1 through 19-5 show the locations of known contaminated sites within 500 feet of the project corridor.

The area proposed for the 85th Street extension is primarily located within railroad and industrial land uses. The database search did not identify any newly listed known contaminated sites in the proposed station location since the DEIS assessment; however, as noted above, contaminated groundwater is reported to be in the area of the underpass. Phase II sampling would be performed prior to property acquisition unless the property can be classified accurately by other means or methods. Should contaminated groundwater be encountered during construction of the 85th Street Extension's underpass through the elevated CSX line or the 91st Street Station, remediation efforts would be implemented to remove the contaminated water.

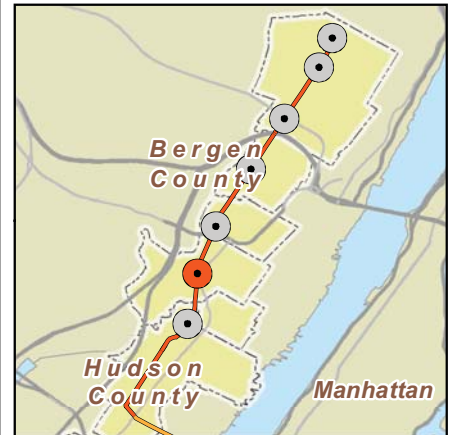
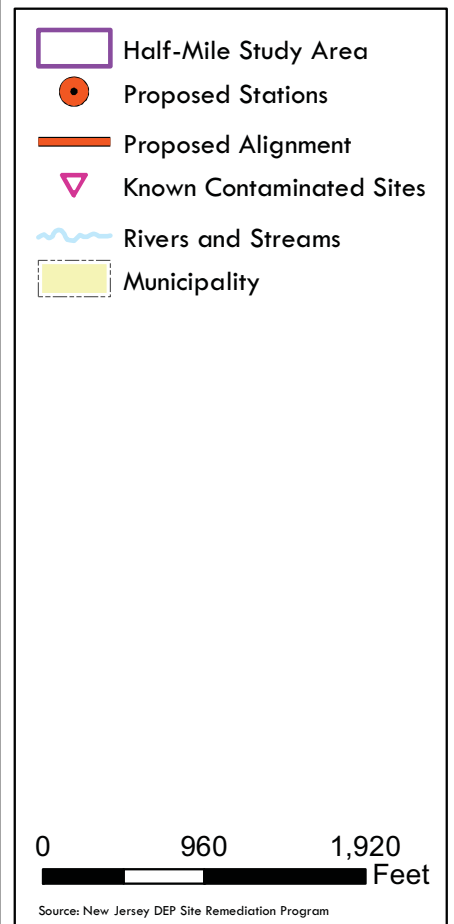
Figure 19-2

Northern Branch Ridgefield Station Hazardous Materials Sites

The proposed Ridgefield Station site contains older commercial and industrial properties on either side of the rail right-of-way. One newly recorded NJDEP known contaminated site is located at 501 Hillside Street on the east side of the alignment near U.S. Route 1 with potential groundwater contamination from a homeowner UST. No visible evidence of hazardous waste was observed at the proposed station site and is unlikely that hazardous materials will be encountered during the development of Ridgefield Station; however, the potential for disturbance of hazardous materials remains given the nature of the adjacent industrial land uses.

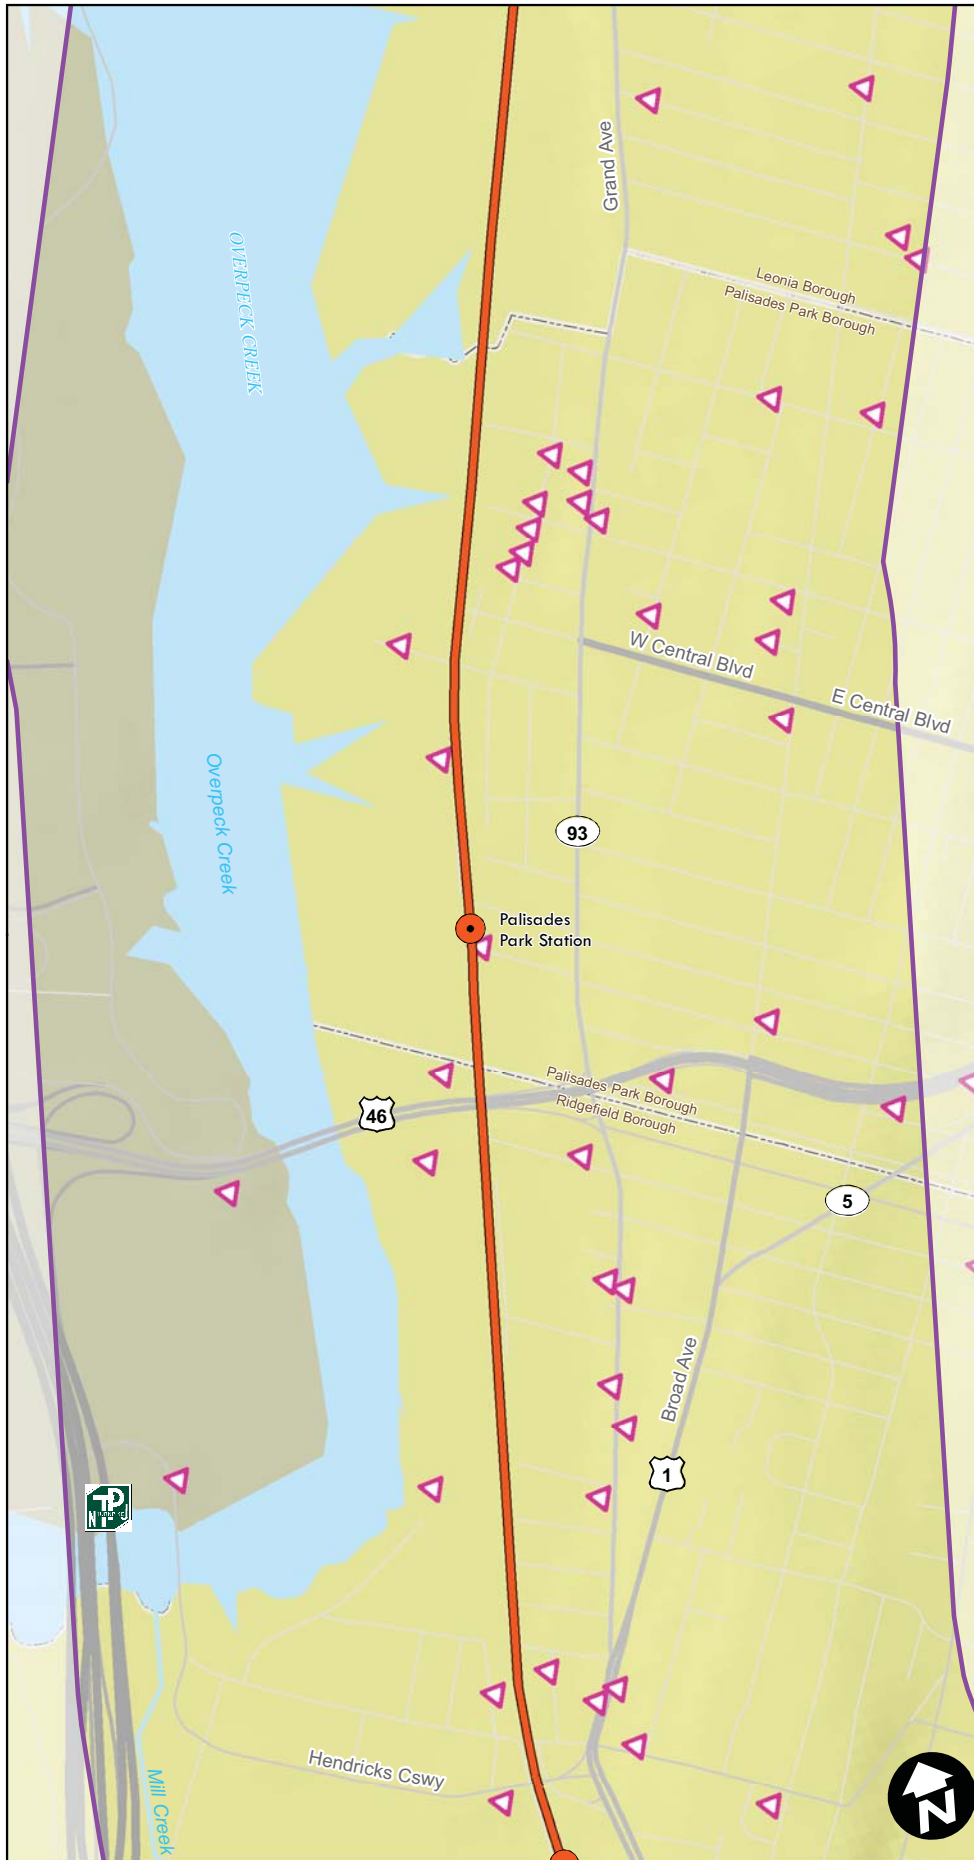
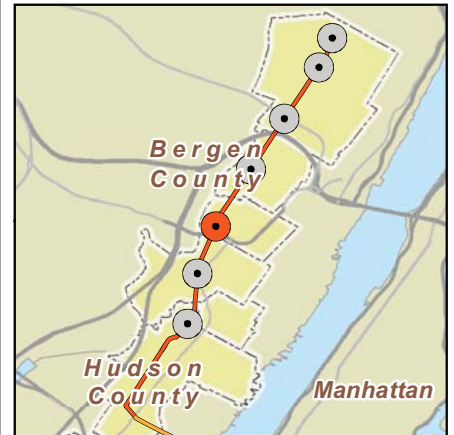
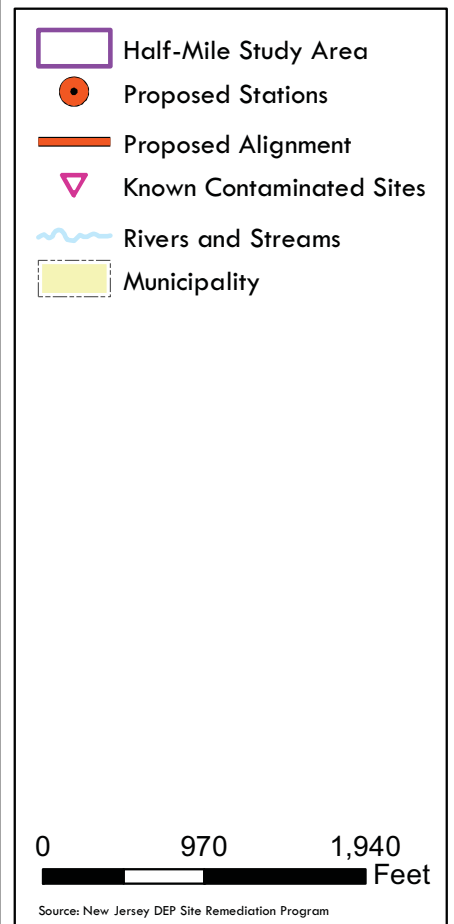
Figure 19-3

Northern Branch Palisades Park Station Hazardous Materials Sites

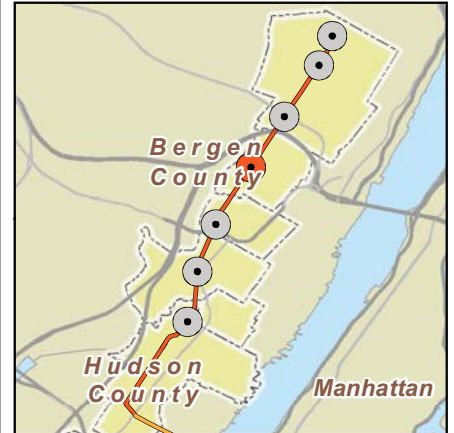
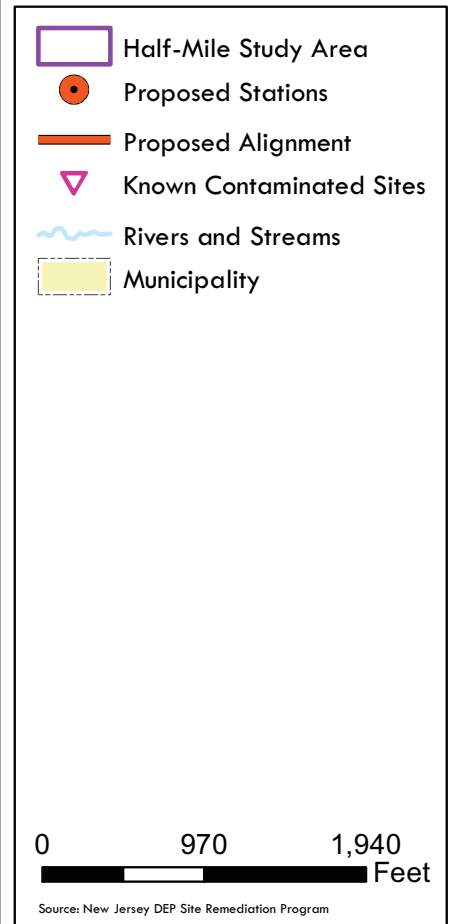
Figure 19-4

Northern Branch Leonia Station Hazardous Materials Sites

Leonia Station platforms are proposed to be located in the existing Northern Branch right-of-way, south of Fort Lee Road. The four-story parking deck and pedestrian walkway to the platforms are proposed to be located in the Leonia South Area of Overpeck County Park, on land currently developed with an abandoned paved basketball court and restroom facility. The NJDEP database search did not identify any hazardous waste sites and no visible evidence of hazardous waste was observed at the proposed station site; however, NJDEP's database indicated that the park was built on historic fill. Soil borings collected to test the geotechnical suitability of the site indicated that the site has been filled with soil, miscellaneous construction debris, and coal cinders. The geotechnical samples were not tested for contaminated materials as geotechnical protocols are different from hazardous materials sampling protocols, and the first soil test was necessary to determine whether the proposed parking deck site was buildable. While it is unlikely that hazardous materials will be encountered during the development of Leonia Station, Phase

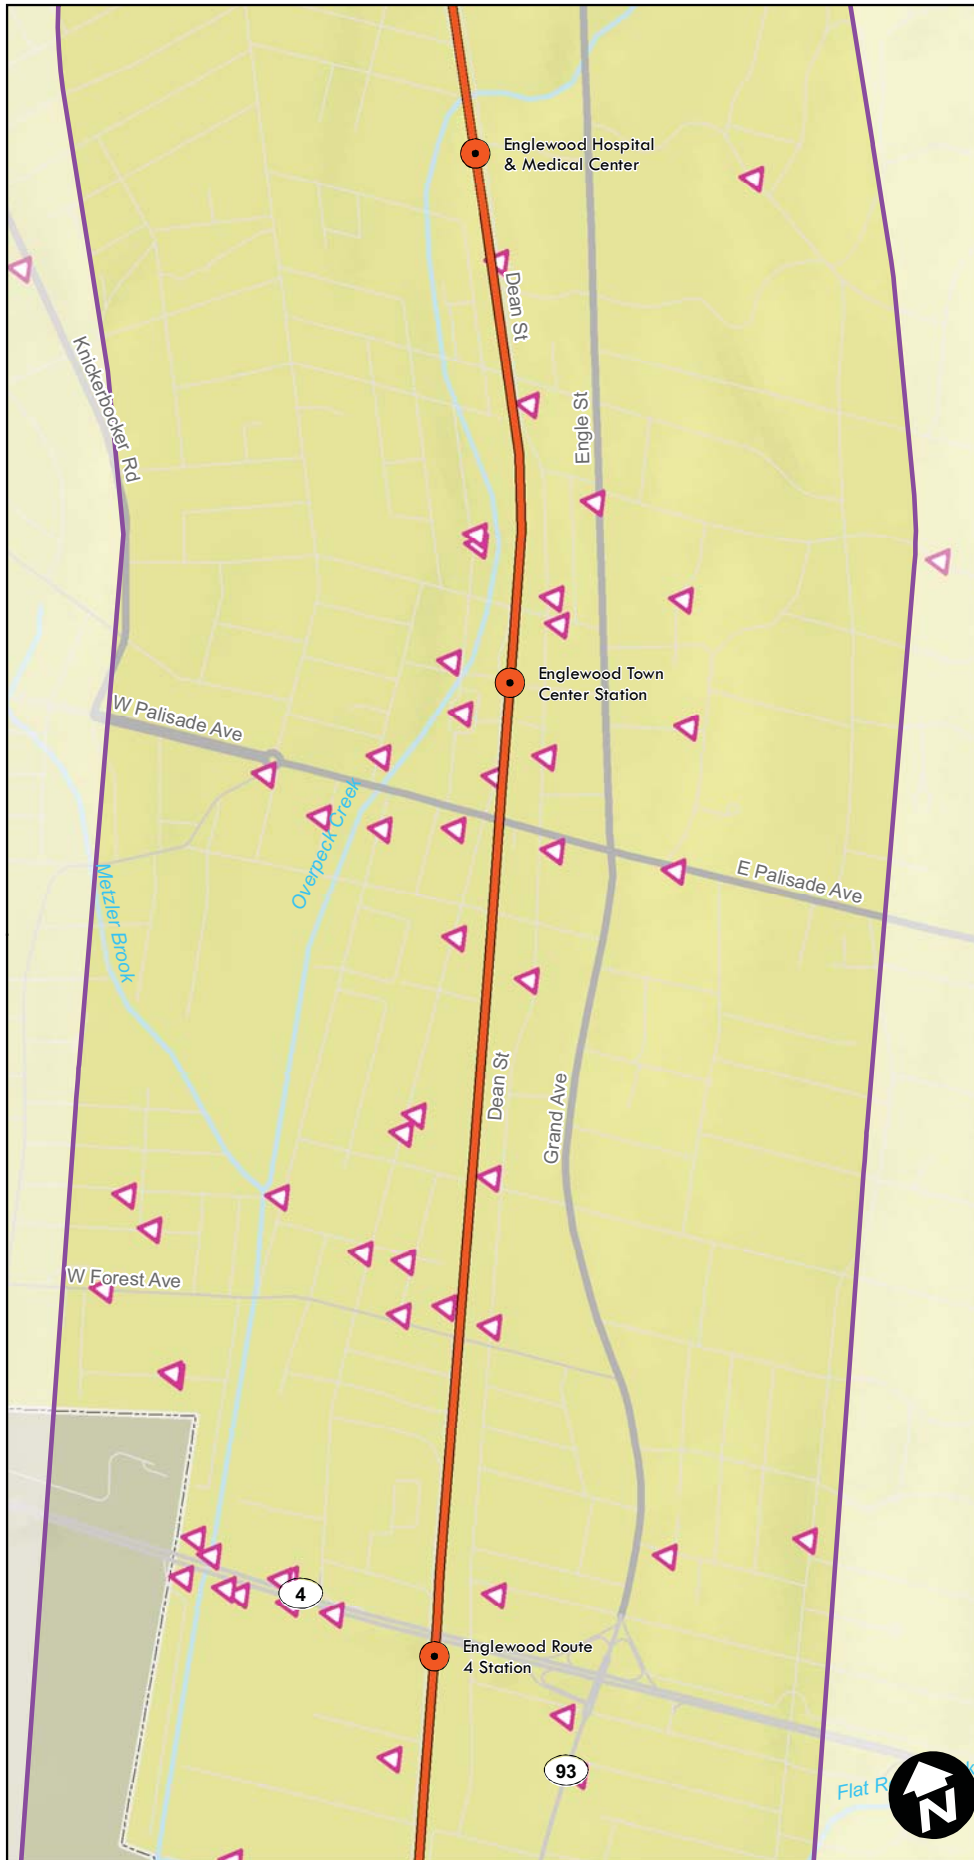
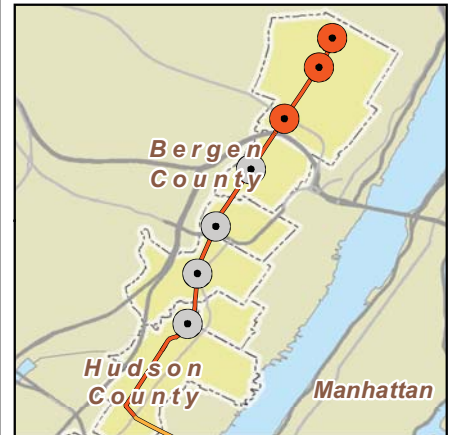
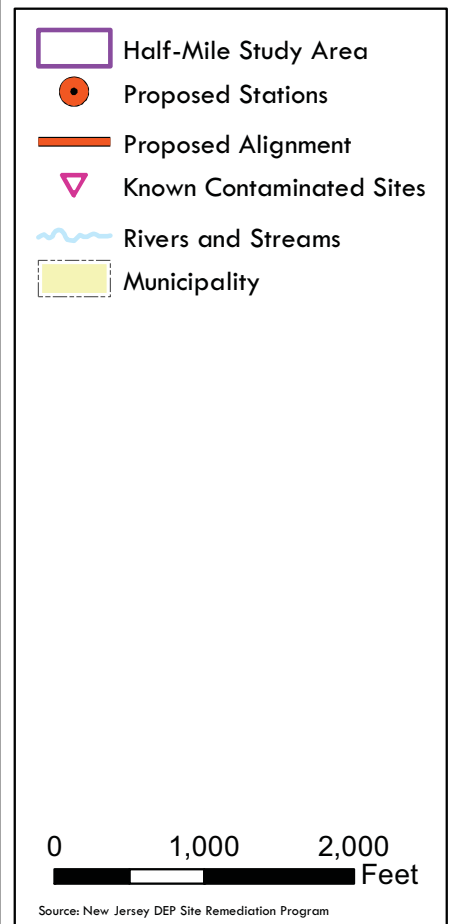
Figure 19-5

Northern Branch Englewood Stations Hazardous Materials Sites
